Contamination and Decontamination of a Light Armoured Vehicle

TECHNICAL MEMORANDUM

DRDC Ottawa TM 2002-107

October 2002

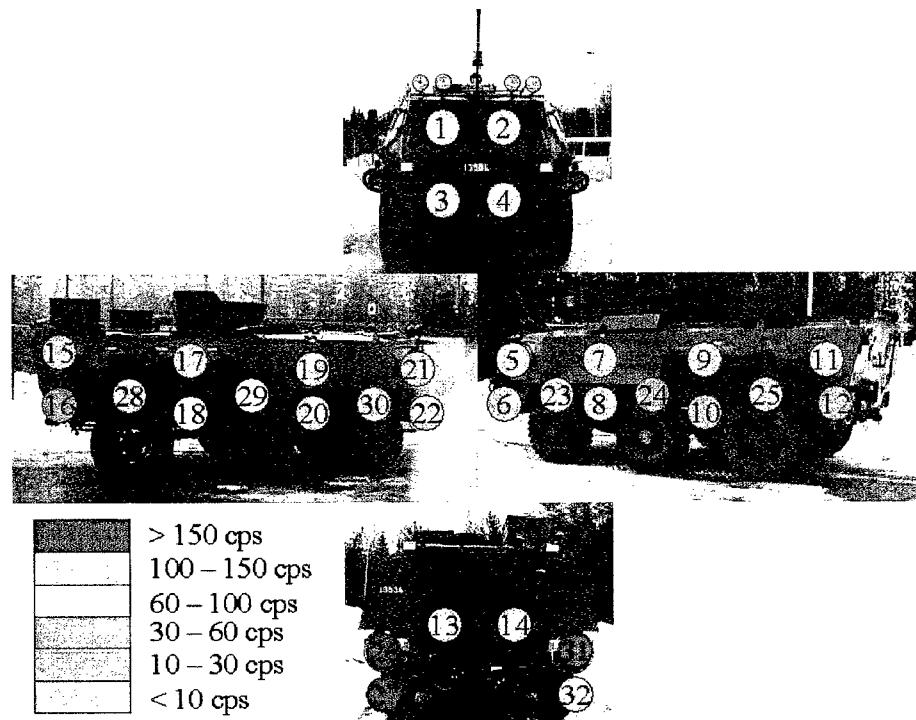
The contamination levels on the vehicle follow a relatively predictable pattern. Namely, very little contamination collects on the front or rear of the vehicle, or anywhere on the upper half of the vehicle. On the other hand, significant contamination can accumulate on the lower halves of the vehicle sides, especially in the wheel wells. It is worth noting that positions 26, 27, 31, and 32 are on or around the two propellers at the rear of this amphibious vehicle. However, because of the vehicle design, this part of the vehicle is essentially part of the wheel wells for the rearmost wheels. These are the most highly contaminated surfaces on the XA-180. It is quite reasonable that the wheel wells are contaminated to the highest level, since the tires are responsible for "kicking up" the contamination. However, it is also worth noting how little contamination ends up in some of the other areas under the wet conditions prevailing during these trials.

Figure 4. Contamination levels on the XA-180, as measured with the ABP-100 alpha-beta probe. Each circle denotes a measurement location, colour-coded according to the magnitude of the measurement (actually the average of the two contamination measurements). Each bubble contains the location number by which the locations are identified in this document.

The vast majority of these measurements are below detectable limits. In fact, the only measurements showing significant levels of contamination are at positions 23 through 30, the wheel wells and the driver's side propeller housing. Decontamination in these areas is hampered by two key factors. First, these surfaces are more difficult to access than vehicle sides. Second, there are spots of corrosion in the wheel wells that might be expected to accumulate contamination and be difficult to flush. This appears to have held true for both the conventional and VLN attempts.

Approximately two-thirds of the locations were decontaminated below detectable limits by both systems. Two locations (26 and 27) were also decontaminated to a great degree, although not necessarily below detectable limits. Three more locations (5, 6, and 13) had small but measurable residual levels of contamination after decontamination, although no measurable levels had been present before. This is presumably the result of contamination splashing from one location to another during the decontamination process. In these cases, however, the activities involved are small. This leaves five vehicle locations with significant non-null results. These are locations 23, 24, 25, 28, and 30, all of which are in the wheel wells. The results for each of these are summarised below:

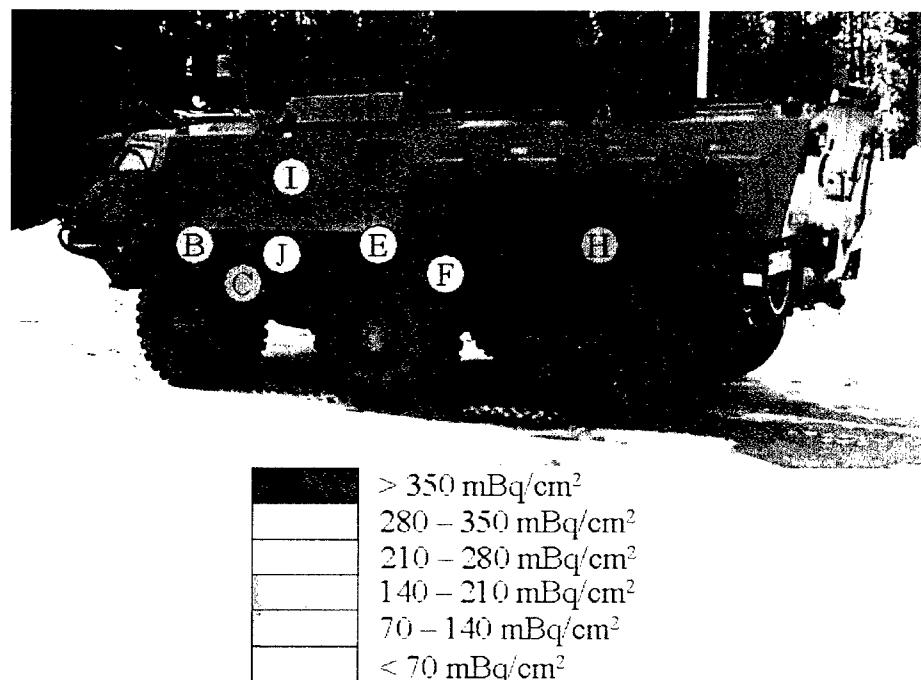
Because swipes were taken largely in similar areas, there are few general conclusions that can be drawn about vehicular contamination. However, one can easily see that the swipe data support the earlier observation that contamination did not collect on the upper half of this vehicle. No differentiation can be made, however, between the data collected from the other nine locations.

Figure 5. Contamination levels on the XA-180, based on swipe measurements. Locations A-H are located in the wheel wells of the vehicle. The letters denoting the position are used throughout this document.

- Location B: both methods left 10-20% of the initial contamination. This location correlates with probe position 23 (driver's side front wheel well), where residual contamination was also observed with the probe.
- Location H: both methods left 30-50% of the initial contamination. This location corresponds to probe position 25 (driver's side rear wheel well), where decontamination was also observed to be poor according to the probe measurements. It should be noted that the residual percentages are lower for the swipes than for the probes, implying a component of "non-removable" contamination.
